**VERIDIAN ON-SITE AIR BAG INFLATOR FAILURE
INVESTIGATION**

VERIDIAN CASE NO. CA00-058

VEHICLE - 1999 PONTIAC GRAND PRIX GT

CRASH DATE - JULY, 2000

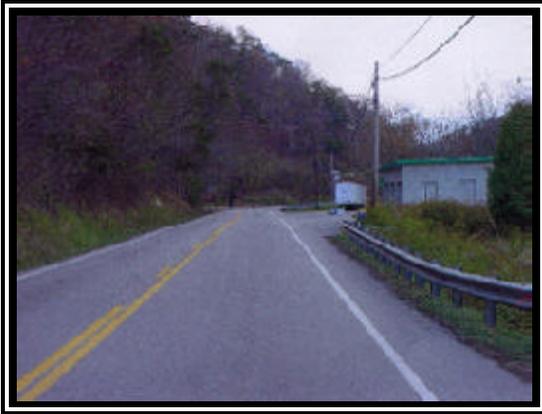
The 17 year old female driver of the 1999 Pontiac Grand Prix GT 2-door coupe was operating the vehicle eastbound (**Figure 1**) when she slowed for traffic ahead. As traffic ahead cleared, the Pontiac driver began to accelerate to a (driver reported) speed of 48 km/h (30 mph) when she observed the westbound Ford encroach into her lane of travel. The Pontiac driver reported no avoidance maneuvers in anticipation of the impending crash.

Figure 1. Eastbound approach for the 1999 Pontiac Grand Prix GT.

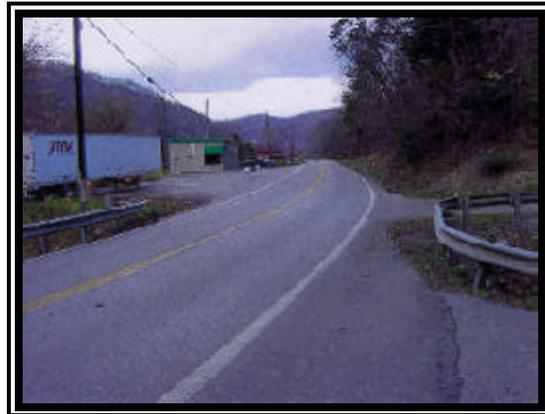
The 23 year old female driver of the 1994 Ford Mustang GT 2-door coupe was operating the vehicle westbound (**Figure 2**) at a (police reported) speed of 89 km/h (55 mph) when she completed a left curve in the roadway and reportedly encountered a (non-contact) westbound vehicle stopped ahead. The Ford driver maneuvered the vehicle into the eastbound lane in avoidance of the stopped vehicle ahead, and into the path of the eastbound Pontiac. Although police witnesses did not confirm the existence of the stopped (non-contact) vehicle, a possibility exists the Ford driver may have been distracted and failed to observe the stopped (non-contact) vehicle; or just improperly negotiated the previous curve, thereby overcorrecting any steering maneuvers.

Figure 2. Westbound approach for the 1994 Ford Mustang GT.

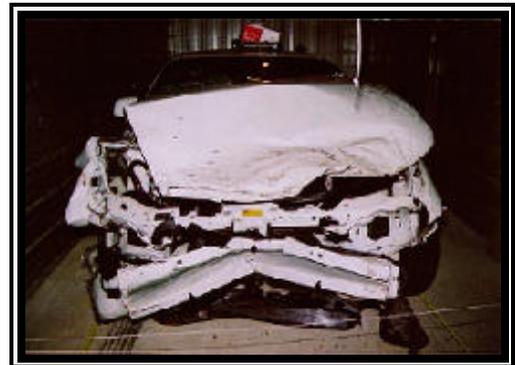
The 1999 Pontiac Grand Prix GT sustained moderately severe frontal damage as a result of the impact with the Ford Mustang (**Figure 3**). The direct contact damage encompassed the entire frontal width resulting in a combined direct and induced damage length (Field L) of 110.0 cm (43.3 in). Six crush measurements were documented at the level of the reinforcement bar (*bumper fascia separation*): C1= 0 cm, C2= 27.5 cm (10.8 in), C3= 47.5 cm (18.7 in), C4= 48.5 cm (19.1 in), C5= 41.5 cm (16.3 in), C6= 26.5 cm (10.4 in), *maximum crush between C3 and C4= 55.5 cm (21.9 in)*. The Collision Deformation Classification (CDC) for this impact to the Pontiac was 11-FDEW-3 with a principal direction of force of (-) 20 degrees. Although the crush was concentrated mainly along the front right and center portions of the end structure, contact damage was documented across the entire front end width of the bumper cover and leading edge of the hood. An indentation was also identified to the center portion of the reinforcement bar attributed to the front right bumper corner of the opposing Ford. The hood was displaced up and rearward from the impact force. The right fender was deformed rearward which restricted the right front wheel/tire (not deflated). Bloody hand prints were noted along the (exterior) left door and window frame, attributed to the driver as she exited the vehicle post-crash. The windshield was fractured from (exterior) impact forces and the (interior) passenger air bag flap. Reduction in the right wheelbase measured 9.0 cm (3.5 in) as the left wheelbase was elongated 3.5 cm (1.4 in).

Figure 3. Frontal damage to the 1999 Pontiac Grand Prix GT.

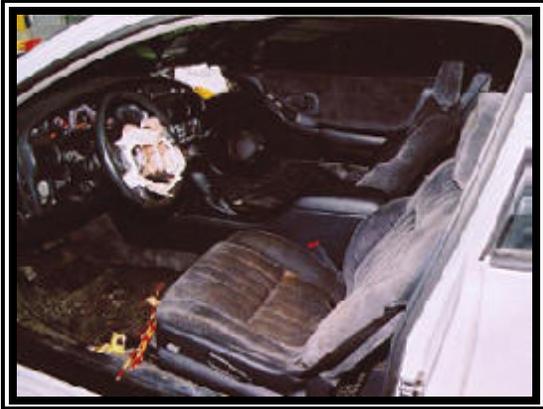
Interior damage to the Pontiac identified through the vehicle inspection was moderately severe and was attributed to occupant contact and the driver air bag inflator failure (**Figure 4**). Scuff marks were documented to the left knee bolster. Indentations and hair strands were identified along the left roof, sunvisor and A-pillar. The left portion of the headliner was abraded with particulate burns and occupant contact scuff marks (**Figure 5**). Steering wheel rim deformation measured 2.0 cm (0.8 in) along the top portion and 3.5 cm (1.4 in) along the right portion. Column compression measured 7.0 cm (2.8 in) which resulted in separation of the sheer capsules from the sheer plate. A heavy concentration of blood and particulate burns were noted along the left interior door panel with bloody hand prints to the (interior/exterior) door panel and upper window frame. Scuff marks were documented to the glove compartment door which was also out of place. No intrusions were found within the vehicle.

Figure 4. Interior view of the 1999 Pontiac Grand Prix GT.

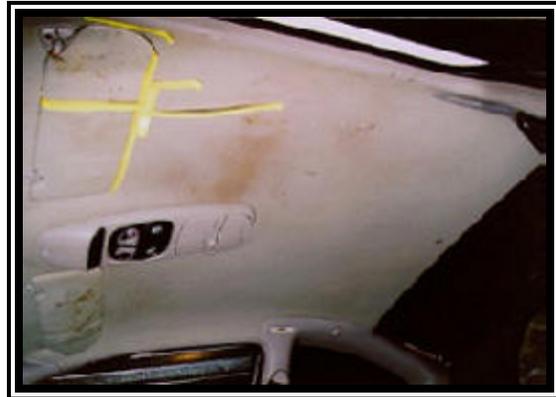
Figure 5. Driver contact evidence and air bag particulate burns to the headliner.

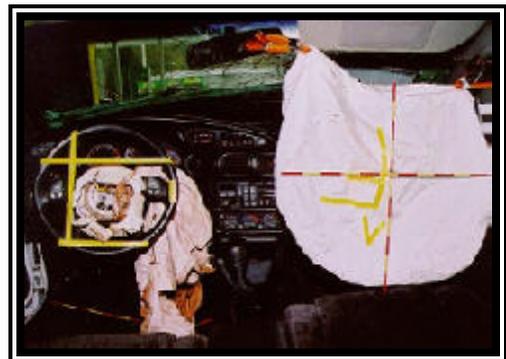
The 1999 Pontiac Grand Prix GT was equipped with frontal air bags for the driver and front right passenger positions. The air bags deployed as a result of the crash (**Figure 6**). The driver air bag module was housed in the center of the steering wheel (**Figure 7**) with a vertically oriented flap tear seam (I-configuration). The flaps were

Figure 6. 1999 Pontiac Grand Prix GT deployed redesigned frontal air bag system.

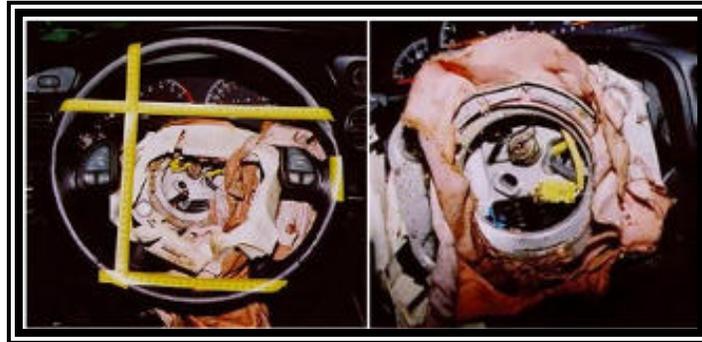
Figure 7. 1999 Pontiac Grand Prix GT deployed redesigned driver air bag module.

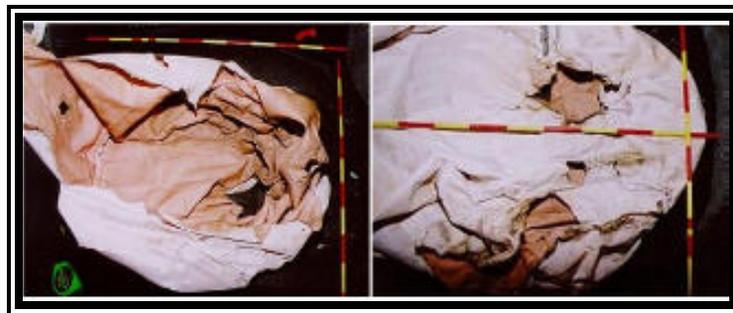
symmetrical in shape and measured 7.8 cm (3.1 in) in width and 11.0 (4.3 in) in height. The module flaps and adjacent trim flaps separated from the housing and were found scattered about the vehicle interior. The air bag membrane was noted to be torn/ruptured (**Figure 8**) and partially attached to the module at the 6 o'clock sector. The diameter of the driver air bag measured approximately 68.0 cm (26.8 in) in its deflated state. The bag was vented by two ports located at the 3 o'clock and 9 o'clock sectors on the rear aspect of the air bag. No internal tether straps were present.

Figure 8. Deployed driver air bag (front/back).

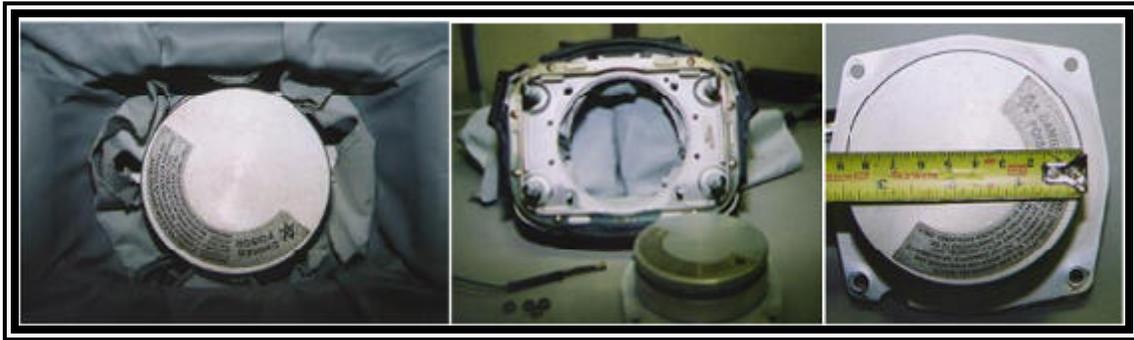
Based on an examination of an exemplary inflator received from General Motors February 15, 2001 (**Figure 9**), the subject inflator unit was constructed of two halves of a cast aluminum alloy metal that were threaded together with an internal thread design. The internal compartment of the inflator contained the initiator, a canister of propellant, and a series of steel mesh screens that acted as a filtering medium (**Figure 10**). Radial ports transferred the gas from the combustion chamber, through the internal wall at the threaded union, through a second stage of filtering medium, and out the side aspect of the inflator. The base/perimeter of the alloy casting was knurled and pressed into the aluminum mounting bracket. The bracket was bolted to the module bracket and secured to the steering wheel with four bolts. At deployment, the casting failed to contain the internal burn process of the generant. As a result, the center disk-like segment of the inflator “blew out” of the casting (**Figure 11**). Although initially thought to be an integral part of the inflator’s design, this large disk-like segment actually separated from the top portion of the inflator. Without a metallurgical analysis of the inflator to look for certain characteristics of possible fracture sites, several possibilities exist as a reason for the inflator failure. Bad casting, too much generant, contaminates in the screen or a plugged filter screen could have produced an excessive build-up of pressure within the inflator.

Figure 9. Exemplary deployed driver air bag module disassembled for SCI analysis.

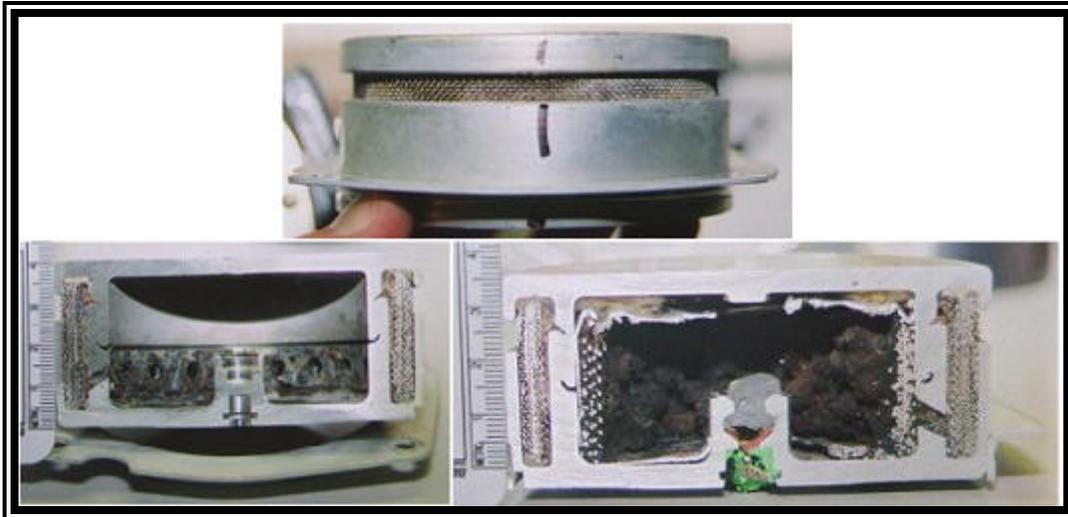
Figure 10. Exemplary inflator unit sectioned for SCI analysis (cross section view).

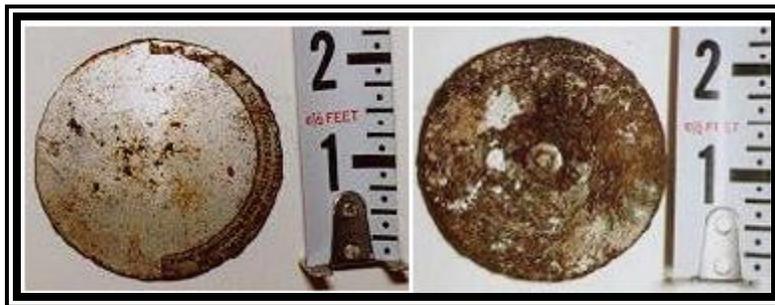
Figure 11. Charred disk-like segment of the failed inflator.

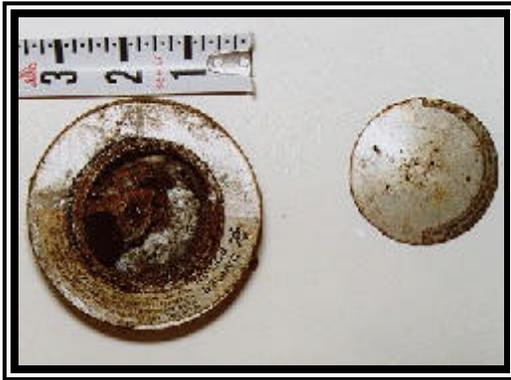
Although the driver air bag module part/serial numbers were unidentifiable, the separated air bag inflator and large disk-like segment (**Figure 12**) were identified by the General Motors part number: 16822766 with a bar coded lot number of: IECL0I252A1135. A discrepancy in the part number was noted between the subject inflator and the exemplary inflator received for analysis. While similar in size and design, the exemplary inflator required a 1.75 amp electrical current for deployment whereas the subject inflator required a 1.2 amp current. A third distinguishable number was identified on the back of the subject inflator unit, however, certain digits were destroyed by a recoil imprint from the steering column rim mounting bolt (**Figure 13**). The inflator unit measured 8.7 cm (3.4 in) in diameter and 3.8 cm (1.5 in) in thickness as the large disk-like segment measured 5.7 cm (2.2 in) in diameter and 0.4 cm

Figure 12. 1999 Pontiac Grand Prix GT failed driver air bag inflator unit and disk-like segment.

As the redesigned driver air bag began to deploy, the inflator failed and the large disk-like segment separated from the main inflator unit which was projected through (ruptured) the membrane of the air bag, towards the driver. The inflator subsequently separated from the module bracket and followed the disk segment through the membrane and into the occupant space. The inflator struck the driver's right face and neck in a "glancing type blow" resulting in an open/comminuted mandible fracture and "charred" lacerations to the cheek/neck with an underlying transection of the mandibular marginal nerve. This injury mechanism was evidenced by the type and location of the injuries relative to the reported final rest position of the inflator in the rear right floor area. Metal shrapnel also found in the rear seating area was discounted as a source of the right facial lacerations given the location and severity of the fractured mandible along the angle. The large disk-like segment was found between the driver seat cushion/door area and probably struck the driver at some point, however, it was not specifically attributed to any injury sustained.

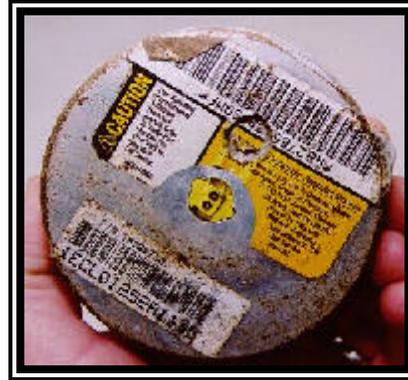
Figure 13. Recoil imprint to rear aspect of failed inflator unit.

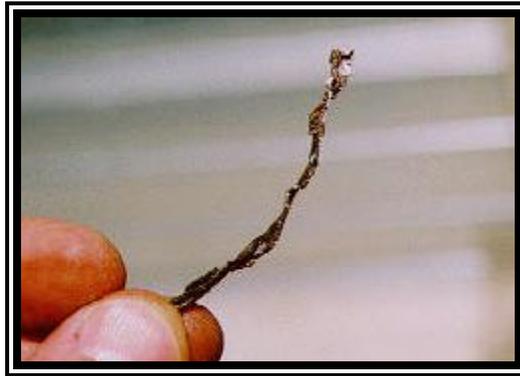
(0.2 in) in thickness. The air bag inflator was later found in the rear right floor area with the igniter missing. The large disk-like segment was later found between the driver seat cushion and door burned and abraded, covered with blood and unidentifiable fabric strands. Metal shrapnel was found embedded into the rear center seat back (**Figure 14**).

Figure 14. Metal shrapnel from inflator unit.

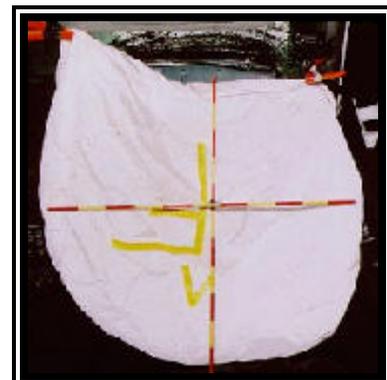
The front right passenger air bag deployed from the right top instrument panel area with a single cover flap design hinged at the forward aspect. The aluminum reinforced cover flap was somewhat rectangular in shape and measured 36.4 cm (14.3 in) in width along the lower portion and 39.2 cm (15.4 in) along the upper portion. The flap measured 27.0 cm (10.6 in) in height along the left edge and 23.7 cm (9.3 in) along the right edge. Glass fragments were embedded into the aft portion of the flap attributed to the windshield impact during bag expansion. No contact evidence was identified on the exterior surface of the cover flap or surrounding instrument panel area. The passenger air bag module was identified by the General Motors part number: *16757542-57* with a bar coded lot number of: *TRAI80115853*. The passenger air bag measured 61.0 cm (24.0 in) in width and 62.5 cm (24.6 in) in height in its deflated state (**Figure 15**). Lipstick transfers were documented to the left centered portion

Figure 15. 1999 Pontiac Grand Prix GT deployed redesigned passenger air bag.

of the air bag face with makeup transfers surrounding the contact site. Blood spattering was noted to the upper left quadrants of the air bag face and side aspect, attributed to the driver's facial injury. Particulate burns (from the driver air bag inflator) were also noted to the upper left quadrant of the passenger air bag face and side aspect. The bag was vented by two ports located at the 10 o'clock and 2 o'clock sectors on the side aspect of the air bag. No internal tether straps were present.

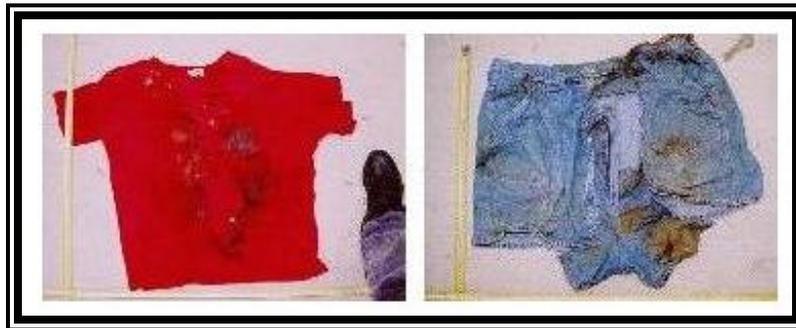
Generant particulates from the inflator sprayed the driver space which resulted in first degree burns across the torso and anterior extremities (4 percent total body surface area), evidenced by the extent of the tissue burns in conjunction with the documented circular spray-patterned singed clothing (**Figure 17**) and burned air bag membrane. Areas of heaviest concentration of particulates to the vehicle interior were noted along the headliner and left door panel. Areas of heaviest concentration to the driver's soft tissue occurred on the face, abdomen and anterior forearms. Skin grafts taken from the driver's thigh were later used to repair a severe burn to the left anterior forearm (wrist to bicep), which was placed on the door armrest pre-crash. Furthermore, medical data reported singed eyelashes/eyebrows with soot found on all four anterior extremities, with specific concentrations noted to the tongue and buccal mucosa. She also sustained a right cornea abrasion and conjunctiva thermal burn resulting in extensive corneal opacification and complete loss of sight.

Figure 17. Charred driver's clothing.
